## Chesterfield Senior Center

## Town of Chesterfield ADA Transition Plan

May 2019

### Senior Center

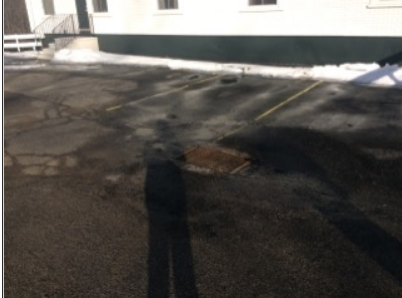
ID	Location	Floor	Room	Element	Type	Photo	Issues	Current Measure	Recommendations	Quantity	Price	Cost Estimation
<b>Approach and Entrance</b>												
<b>Exterior Access Route</b>												
1	Parking Lot	Ext.		Exterior Access Route

Surface openings > 1/2"	3"	Replace or reposition grates so that openings are 1/2" max. and the long opening dimension is perpendicular to the dominant direction of travel.	1	1453	\$1453
<b>Off-Street Parking Lot or Garage</b>												
2	Parking Lot	Ext.		Off-Street Parking Lot or Garage	Visitor

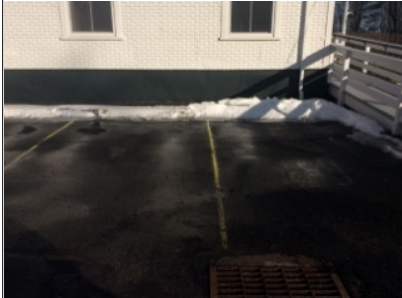
Total # of parking Total # of designated accessible parking spaces Total # of designated van accessible spaces Access aisle not provided Sign not provided	28 1 1 - -	Provide a van accessible space with a marked access aisle that is at least 60". Provide a sign with the bottom of the sign 60" min. above the ground and the top 96" max. above the ground. Add the designation "Van Accessible" to the sign located at the van accessible space.	1	925	\$925

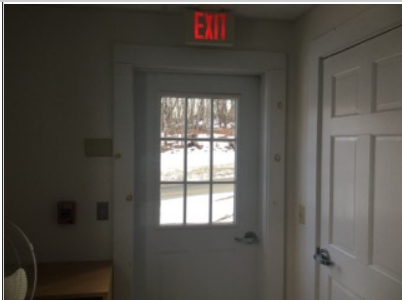
<b>Emergency Exit</b>												
3	Front Emergency Exit (South Side)	B		Emergency Exit	N/A

Emergency exit not on an accessible route	-	Provide an exterior area for assisted rescue. Ensure tactile exit signs with raised characters and braille are provided at exit doors. Mount signs between 48"- 60" above finish floor located on the latch side of the door. Ensure the sign has the International Symbol of Accessibility (ISA). (Cost based on 60" x 60" concrete landing plus sign.)	1	498	\$498
4	Emergency Exit to Parking (Northwest Side)	1		Emergency Exit	N/A

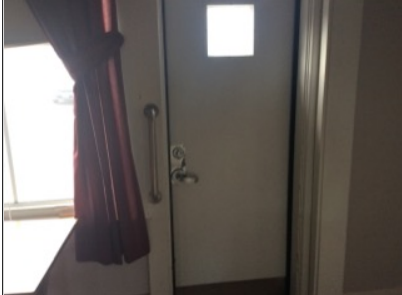
Emergency exit not on an accessible route Directional sign to accessible emergency exit not provided Clear width at door < 32" Level changes > 1/4"	- - 30" 10"	Provide a directional sign indicating the location of the nearest emergency exit. Ensure tactile exit signs with raised characters and braille are provided at exit doors. Mount signs between 48"- 60" above finish floor located on the latch side of the door.	1	116	\$116

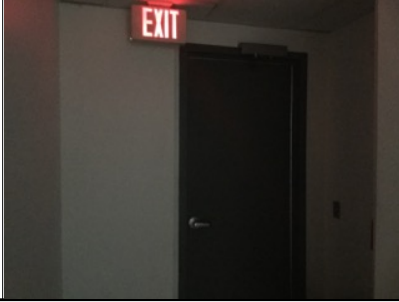
ID	Location	Floor	Room	Element	Type	Photo	Issues	Current Measure	Recommendations	Quantity	Price	Cost Estimation
5	Rear Exit (North Side)	B		Emergency Exit	N/A

Emergency exit not on an accessible route Directional sign to accessible emergency exit not provided Clear width at door < 32"	- - 30.5	Provide a directional sign indicating the location of the nearest emergency exit. Ensure tactile exit signs with raised characters and braille are provided at exit doors. Mount signs between 48"- 60" above finish floor located on the latch side of the door.	1	116	\$116
<b>Access to Goods and Services</b>												
<b>Interior Access Route</b>												
6	Bottom of Staircase	B		Interior Access Route	N/A

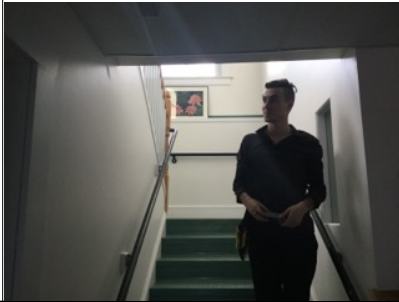
Minimum vertical clearance not provided	75"	Providing the minimum vertical clearance might be technically infeasible.  Consider adding a sign that says, "Low Headroom" or "Low Ceiling".	1	0	\$0

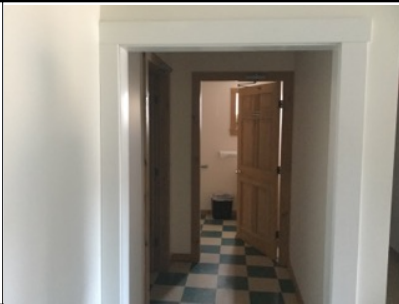
7	Basement Hallway	B		Interior Access Route	N/A

Minimum vertical clearance not provided	76.5"	Providing the minimum vertical clearance might be technically infeasible.  Consider adding a sign that says, "Low Headroom" or "Low Ceiling".	1	0	\$0
<b>Doors, Doorways, &amp; Gates</b>												
8	Single-User Toilet Room	1		Doors, Doorways, & Gates	Toilet Room

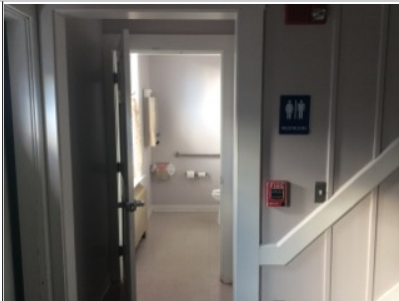
Maneuvering clearance(s) not provided	-	Provide an automatic door opener.	1	1530	\$1530

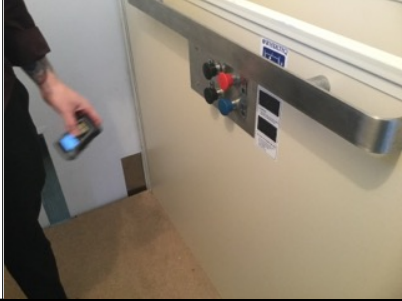
ID	Location	Floor	Room	Element	Type	Photo	Issues	Current Measure	Recommendations	Quantity	Price	Cost Estimation
<b>Platform Lift or LULA Elevator</b>												
9	Lift	B		Platform Lift or LULA Elevator	Interior

36" x 48" clear floor space not provided (if end door)	32.5" x 55"	Lift does not compliant with the 2010 ADA Standards but is usable.	1	0	\$0
<b>Signage</b>												
10	Meeting Room	B		Signage	Designation

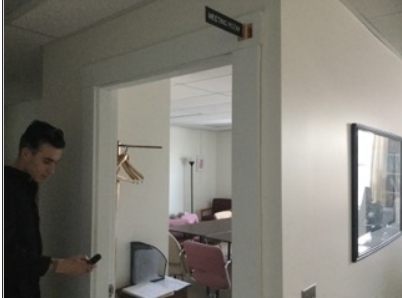
Raised characters not provided Braille not provided Sign not located on the latch side of the door	- - -	Provide text with raised characters duplicated in braille. Locate sign on the latch side of the door.	1	116	\$116
11	Women's Toilet Room	B		Signage	Designation

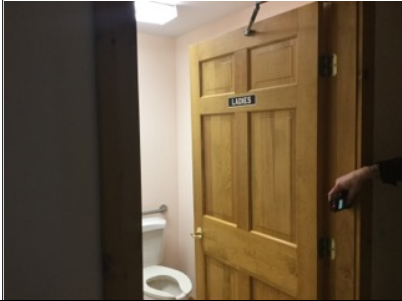
Raised characters not provided Braille not provided Sign not located on the latch side of the door	- - -	Provide text with raised characters duplicated in braille. Locate sign on the latch side of the door.	1	116	\$116

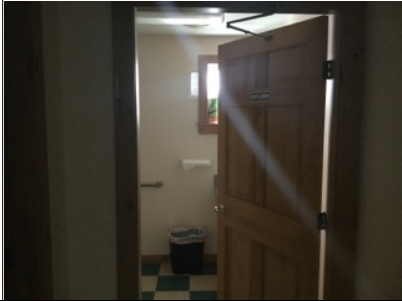
12	Men's Toilet Room	B		Signage	Designation

Raised characters not provided Braille not provided Sign not located on the latch side of the door	- - -	Provide text with raised characters duplicated in braille. Locate sign on the latch side of the door.	1	116	\$116
<b>Dining or Work Surfaces</b>												
13	Computer Station	B		Dining or Work Surfaces	Work Surface

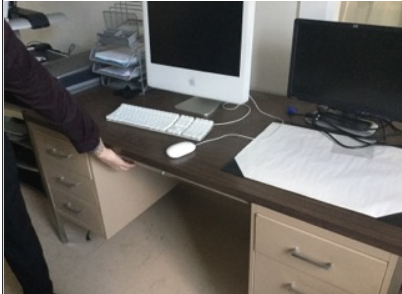
Knee or toe clearance not provided	25"	Provide a work surface with 27" min. knee and toe clearance.	1	350	\$350

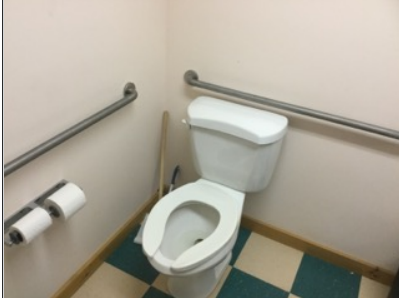
ID	Location	Floor	Room	Element	Type	Photo	Issues	Current Measure	Recommendations	Quantity	Price	Cost Estimation
<b>Toilet &amp; Bathing Rooms</b>												
<b>Single-User Toilet</b>												
14	Men's Toilet Room	B		Single-User Toilet	N/A

Flush control not on open side	-	Relocate the flush control to the open/transfer side.	1	187	\$187
15	Single-User Toilet Room	1		Single-User Toilet	N/A

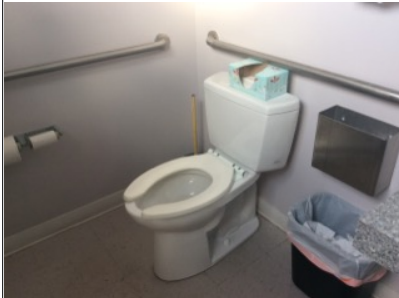
Flush control not on open side Centerline < or > 18" (MAAB)	- 22"	Relocate the flush control to the open/transfer side. Relocate toilet so that the centerline is 18" from the side wall.	1	1601	\$1601
16	Women's Toilet Room	B		Single-User Toilet	N/A

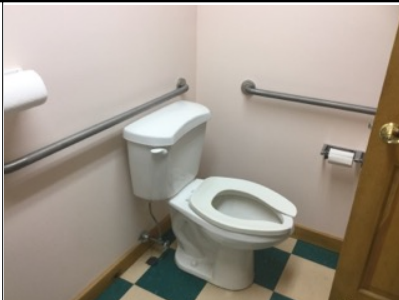
Hook located > 48" high	66"	Locate hook no higher than 48" above the finish floor.	1	Labor	\$0
<b>Dispensers</b>												
17	Single-User Toilet Room	1		Dispensers	Tampon Dispenser

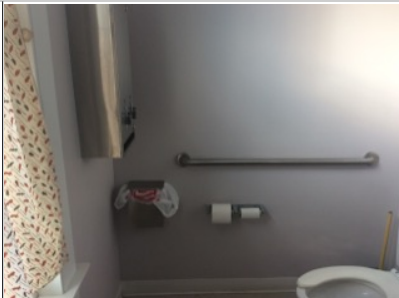
Dispenser acts as a protruding object	7"	Relocate dispenser so it does not protrude into the circulation path.	1	Labor	\$0

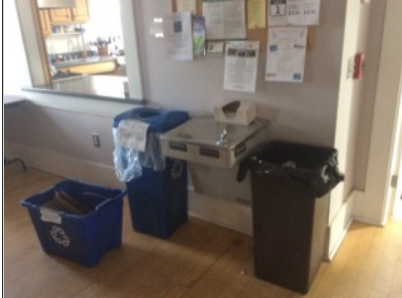
ID	Location	Floor	Room	Element	Type	Photo	Issues	Current Measure	Recommendations	Quantity	Price	Cost Estimation
<b>Drinking Fountains</b>												
18	Main Hall	1		Drinking Fountains	Low

No drinking fountain provided for standing users	-	Provide an additional drinking fountain for standing users. Relocate trash containers to maintain the clear floor space at the accessible drinking fountain,	1	2014	\$2014
19	Drinking Fountain Near Ramp	B		Drinking Fountains	Low

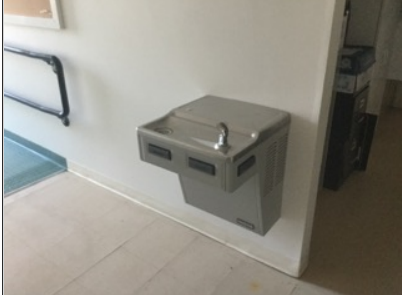
No drinking fountain provided for standing users	-	Provide an additional drinking fountain for standing users.	1	2014	\$2014
