# Center Cemetery Master Conservation Plan

*Chesterfield, Massachusetts*

*Martha Lyon Landscape Architecture, LLC  
Monument Conservation Collaborative, LLC  
CME Associates, Inc.*

2008

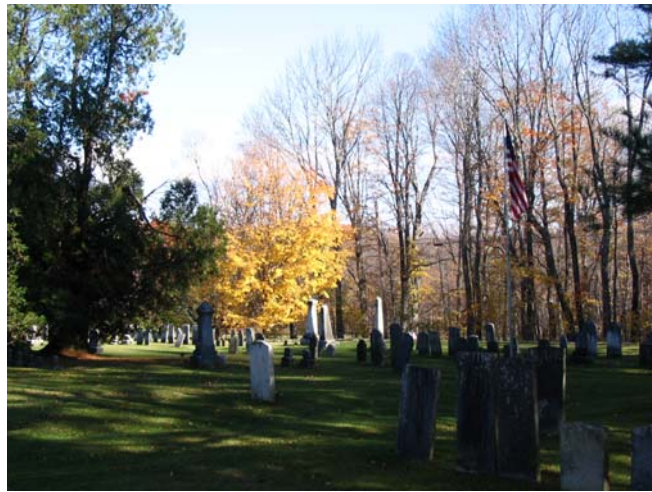
*Figure 1. The Center Cemetery landscape in fall. Even though the Town has continually cared for the cemetery, many of the gravestones and other historic features are in need of conservation treatment.*

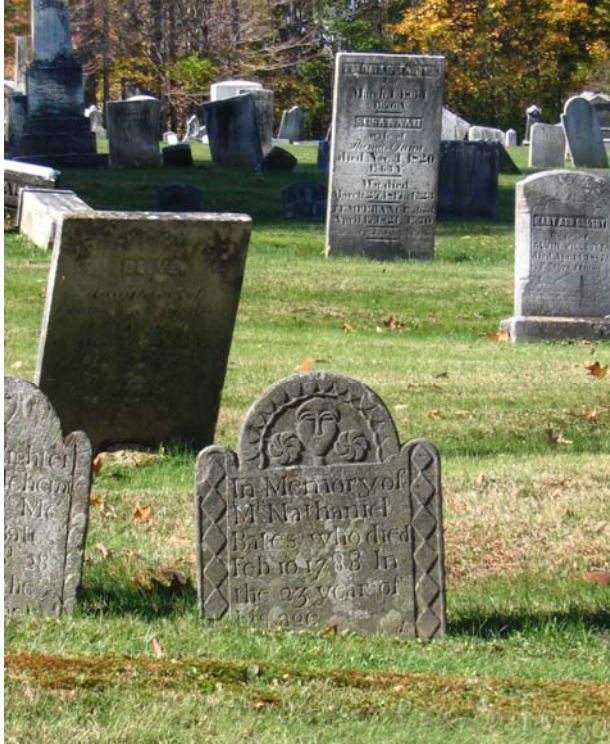
Figure 2. The gravestone of Nathaniel Bates (d. 1788) was carved by Elijah Sikes of Chester. Sikes married Lucretia Anderson, the daughter of Archelaus Anderson. Anderson originally owned the land that in 1764 became Center Cemetery.

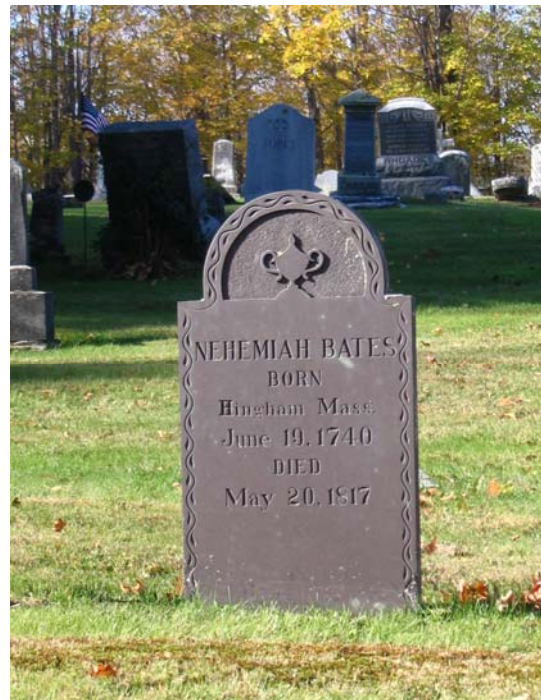
*Figure 3. The stone of Nehemiah Bates is likely a replica of an earlier stone, carved by an unknown local artisan.*

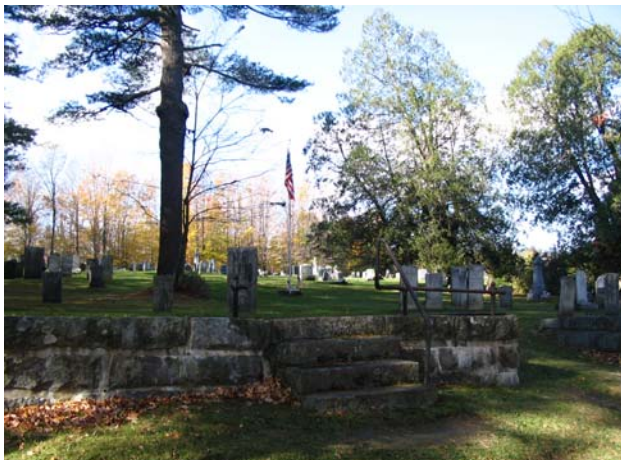
Figure 5. Town Reports indicate that the granite steps were constructed in 1954, in conjunction with several other cemetery improvements.

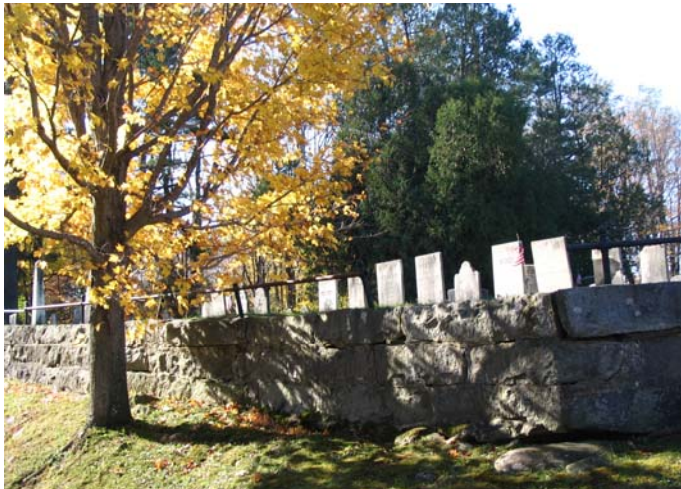
Figure 6. The Center Cemetery granite front wall provides a strong separation between the cemetery and its North Road edge.

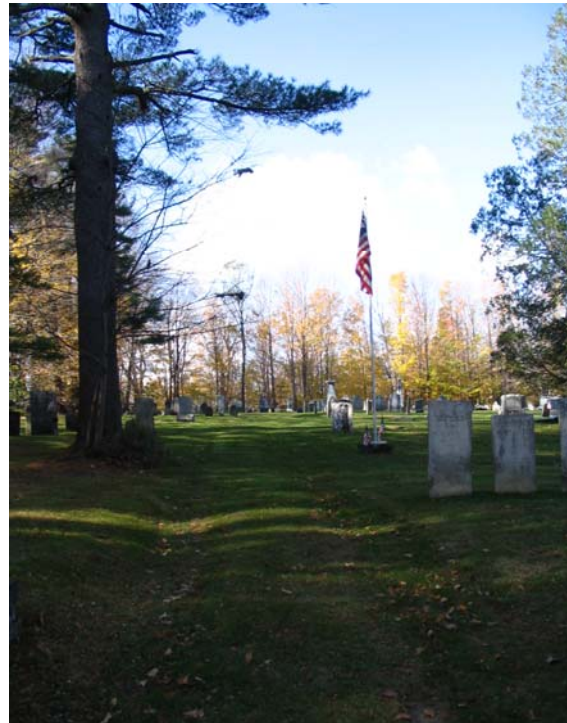
Figure 8. The pedestrian path leading into the Old Section passes the flagpole area and loops through the gravesites.

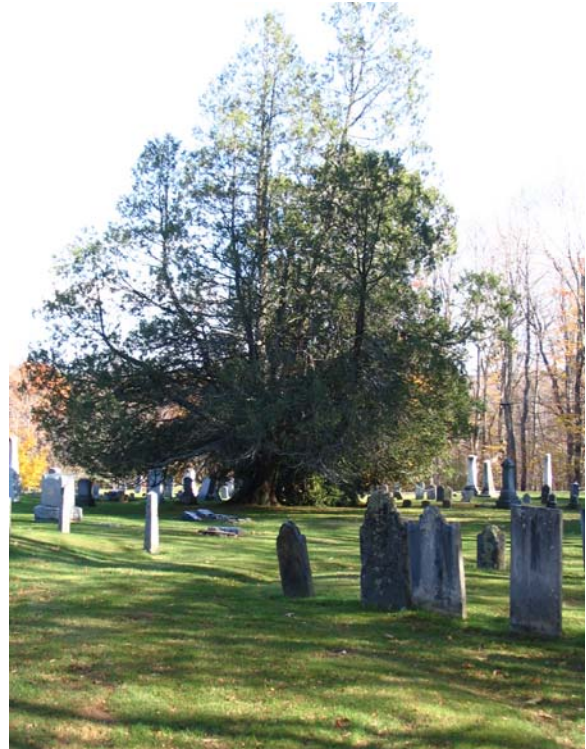
*Figure 10. Two cedars may have been originally planted to ornament gravesites. Now, they are overgrown and appear unkempt.*

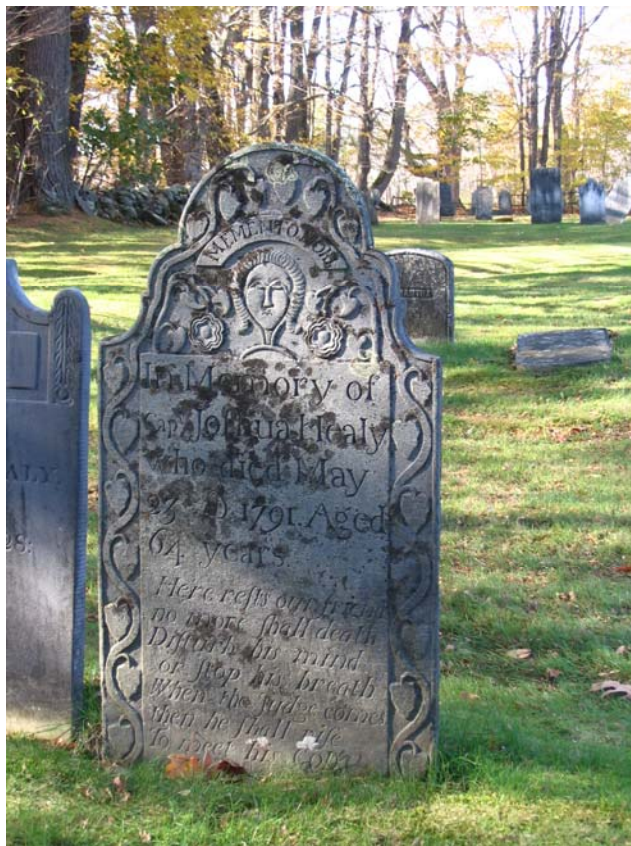
Figure 13. The headstone of Joshua Healy, c. 1791, was attributed by Robert Drinkwater to Elijah Sikes, a stone carver who worked in Chester, Massachusetts, before moving to Dorset, Vermont.

Center Cemetery's gravestones are among its most distinctive features. In 1986, Robert Drinkwater examined the stones, and found the carvings of Nathaniel Phelps (1721-1789), Elijah Phelps (c. 1761-1842), Rufus Phelps (1766-1826, son of Nathaniel), Elijah Sikes (born c. 1770, see *Figure 13*), as well as several other artisans working in the early 19<sup>th</sup> century. The collection bears both local and regional significance for its many examples of early American gravestone art.

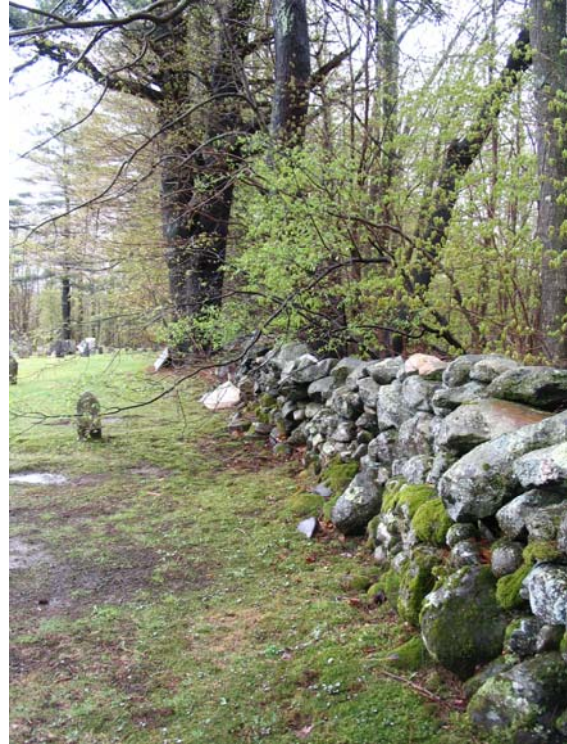
- *The perimeter dry-laid stone wall.* A dry-laid fieldstone wall rims the cemetery's south edge. It is likely that this wall dates to the early days of the cemetery, and was constructed of stones gathered from surrounding farmlands. It stands approximately thirty inches, and contains stones ranging in size from eight to 24 inches in diameter. While the wall is visible across the entire boundary, many of the stones have dislodged, giving it a messy appearance. In some spots, suckering trees have sprouted from among the stones, further weakening the wall.

*Figure 14. The dry-laid stone wall along the cemetery's south edge may be one of its oldest remaining original features.*

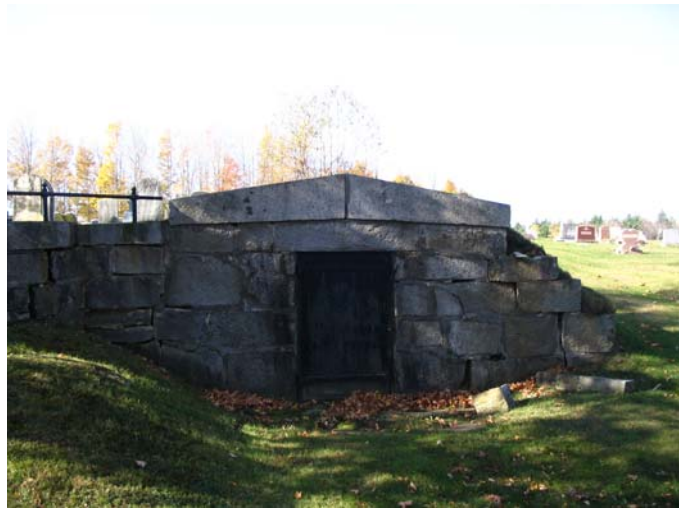
*Figure 16. Preliminary recommendations include stabilizing the tomb structure by rebuilding the façade and installing an improved drainage system.*

- The Town should stabilize the tomb structure (see *Figure 16*) by re-building the façade, replacing soil behind the wall with good quality back-fill material and installing an improved drainage system. The door should also be stabilized, with new paint applied and replacement hinges and latches.
- The Town should begin conservation of the stones identified as needing treatment, beginning with the hazardous group first (97), and continuing with the unstable group (40) and deteriorating group (60).
- The Town should re-establish the flagpole area and add seating to the feature.
- The Town should retain and preserve the cemetery's other historic landscape features.

- Excavating behind the tomb and sealing the roof with a modern waterproofing system;
- Installing a drainage system around the tomb and backfilling the structure with high-quality material;
- Removing and numbering the façade stones, cleaning the stones with masonry cleaner applied at a low pressure, and re-building the façade, setting the stones to their original line and grade; and
- Removing the iron door, removing the paint and laminar rusting, and repainting the door, and reconstructing the handle in a matching style.

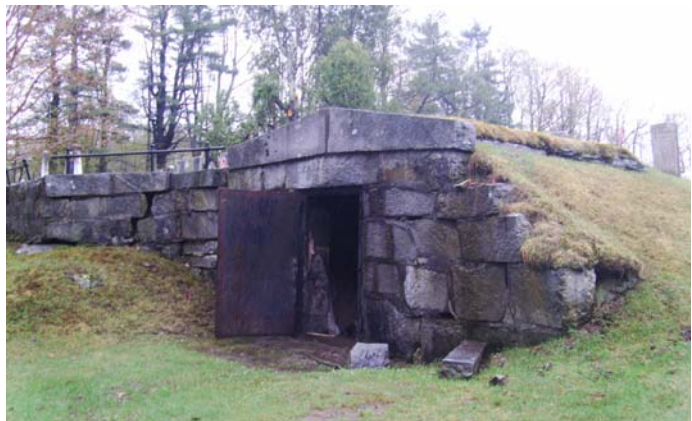
*East Elevation of the Receiving Tomb*

Exterior: The exterior front wall has a noticeable lean at this time, and there are minor sink holes in the topsoil above the front wall. The front wall stones at the north end have shifted significantly. When viewed from the interior, it is apparent that the entire front façade of the tomb has shifted toward

the road. This has opened up gaps between the roof stones and the front façade, which is now allowing water to come in.

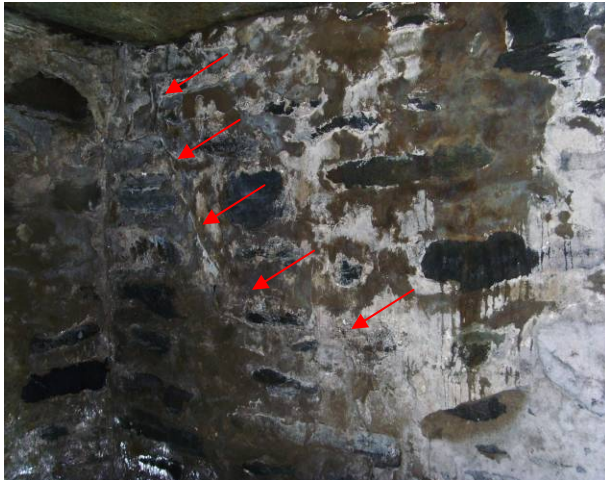
Interior: The tomb was opened for inspection. The interior stonework consists of cut granite walls and a flat slab granite roof. The floor is made up of several granite slab stones. The entire interior of the tomb has been re-pointed several times. The stonework in the interior of the tomb is in fair condition. The rear wall, lower portions of the side walls and the ceiling do not appear to have shifted at all over time; however, the front wall and the upper front portion of the side walls has moved forward approximately 2 inches. There are diagonal cracks running along both side walls from the upper rear portion of the wall to the lower front portion of the wall. The cracks are wider at the top than the bottom. There are no significant cracks in the rear wall.

*North Wall of Tomb Interior  
(Arrows show cracking pattern)*

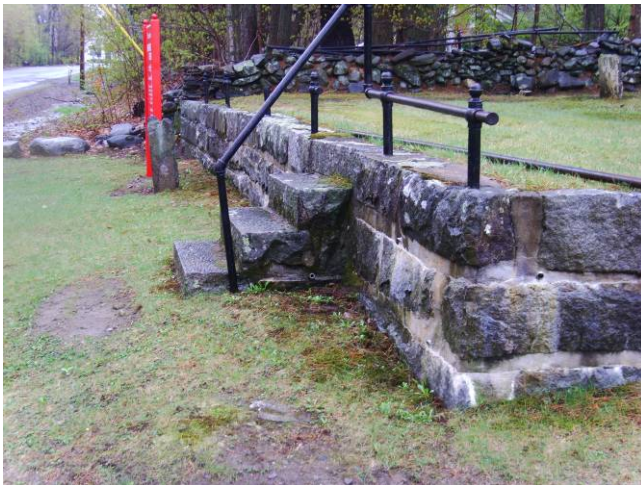
*South Section of Wall Elevation (looking south)*

This wall is a mortared rough cut granite stone wall that is approximately 3 feet tall. This wall is in good to fair condition. All of the stones are in place and there is no appreciable lean or bulges. We have been informed that this wall was re-pointed in

1996. At that time, small polyvinyl chloride plastic pipe weepholes were also installed. The mortar used for the re-pointing has significant efflorescence bleeding from it. Efflorescence is caused by water migrating through the mortar during and after the curing process. The water carries diluted salts that may be present in the mortar mix and draws them to the surface. When the water evaporates, the salt is left behind as a white flaky substance. Efflorescence is not a structural problem, but an aesthetic issue. The remainder of the wall has a natural covering of lichen.

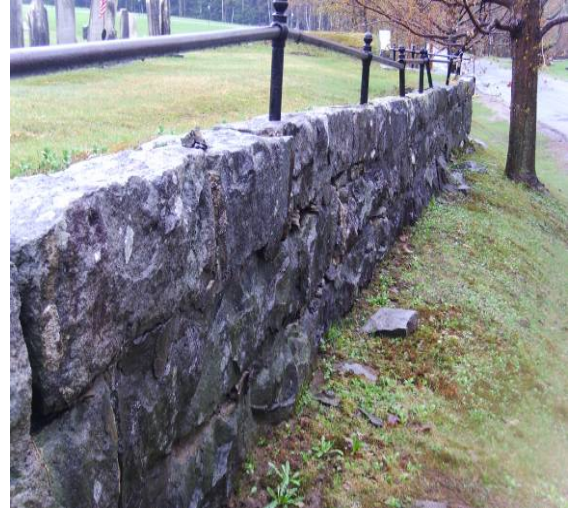
*Northern portion, Center Section*

North half of wall: The northern half of the center section is also a cut rough granite wall; however, it is in much worse condition when compared to the south half. The wall is shifting and bulging. We would classify the condition of this portion of the wall as being in poor condition. The face of the wall has shifted outward, which is a sign of either inadequate design, or high soil pressures due to the presence of water. This type of shifting is technically categorized as a failure. Over time, this movement will get worse and eventually lead to a complete collapse of the wall; however, this is a very slow process.

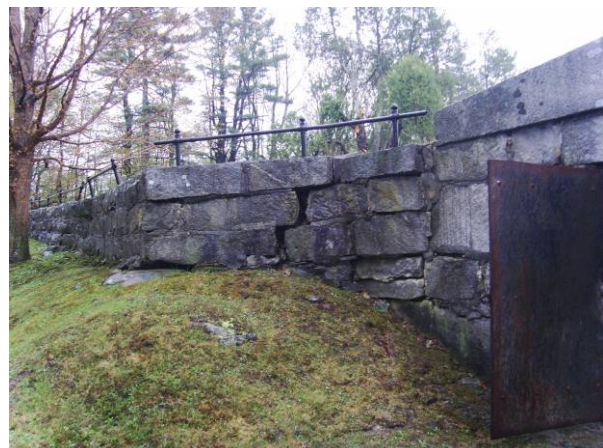
*East Wall near Tomb*

The portion of the wall directly south of the tomb is in very poor condition. The wall in this location has shifted considerably and opened up large voids. There is a large void under the corner of this wall. It does not appear that there are stones below grade. This would need to be verified with a test pit.

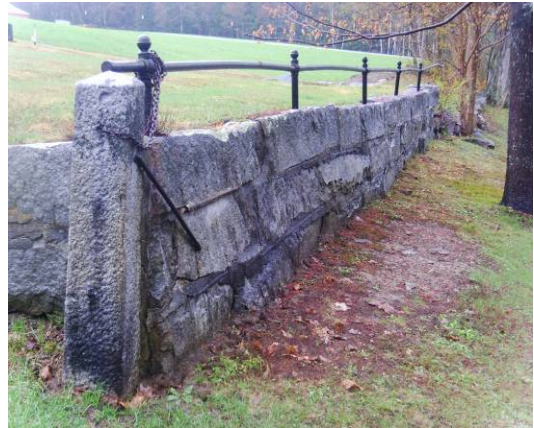
*North Section (looking North)*

This wall has been re-pointed in the past. The pointing is older than the 1996 pointing done to the southeast wall. Most of the steel railing is still in place; however, the condition of the railing is poor.

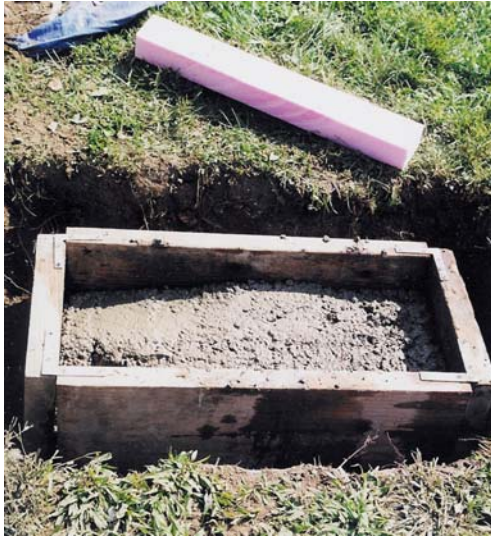
The bases are minimally 12 inches deep, 12 inches greater in thickness and 6 inches wider than the stone itself. Once the concrete has cured, forms are removed and the stones are reset into the slot as above.

*On left, a new base partially filled with concrete and foam setting form in background.*

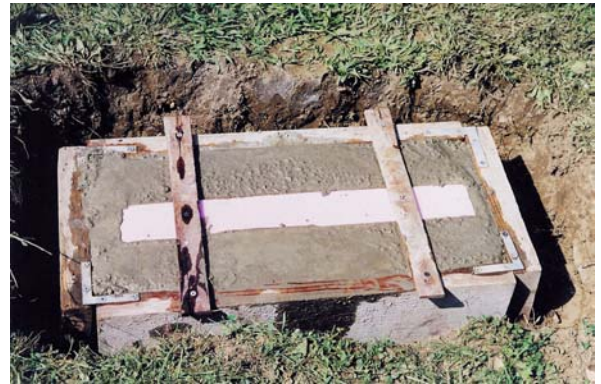
*On the right, the poured base with setting form in place*
