## Highway Department

## Town of Chesterfield ADA Transition Plan

May 2019

Year Built: 1969 Year renovated: 2013

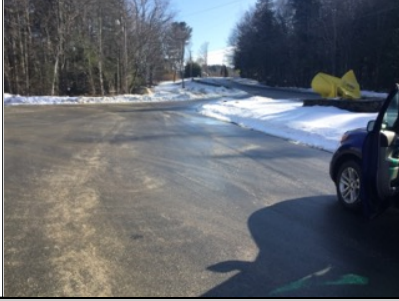
ID	Location	Floor	Room	Element	Type	Photo	Issues	Current Measure	Recommendations	Quantity	Price	Cost Estimation
<b>Approach and Entrance</b>												
<b>Off-Street Parking Lot or Garage</b>												
1	Parking Lot	Ext.		Off-Street Parking Lot or Garage	Visitor

Total # of parking Total # of designated accessible parking spaces Vehicle space < 96" wide at car space Access aisle < 96" wide at van space Sign not provided Sign does not have the designation "Van Accessible" Sign bottom < 60" above finished grade	5 -	Provide a van accessible space that is at least 96" wide with a marked access aisle that is at least 96" wide. Provide a sign with the bottom of the sign 60" min. above the ground and the top 96" max. above the ground. Add the designation "Van Accessible" to the sign located at the van accessible space.	1	400	\$400
<b>Entrance</b>												
2	Main Entrance	Ext.		Entrance	Main Entrance

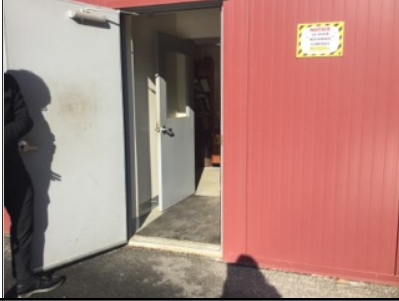
Threshold > 1/2" high	2"	Changes in level greater than 1/2" must be ramped. Consider providing a transition aluminum threshold ramp.	1	75	\$75

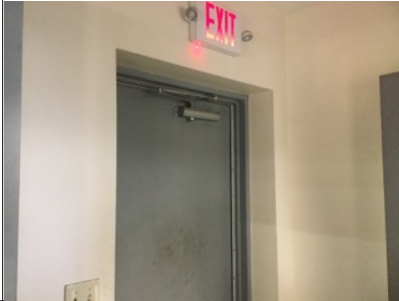
<b>Access to Goods and Services</b>												
<b>Signage</b>												
3	Main Entrance Interior	1		Signage	N/A

Not provided	-	Provide a sign with raised characters duplicated in braille. Locate sign alongside the door on the latch side.	1	116	\$116
<b>Toilet &amp; Bathing Rooms</b>												
<b>Lavatory</b>												
4	Single-User Toilet Room	1		Lavatory	N/A

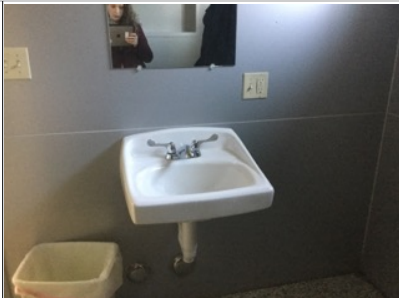
Mirror above lavatory w/reflective surface > 40"	47"	Lower mirror so that the bottom surface is at 40" max. above finish floor.	1	128	\$128
