CONDITIONS SUMMARY, CONSERVATION RECOMMENDATIONS AND CONDITION ASSESSMENTS

HISTORIC CENTER CEMETERY, CHESTERFIELD, MA

May 2008

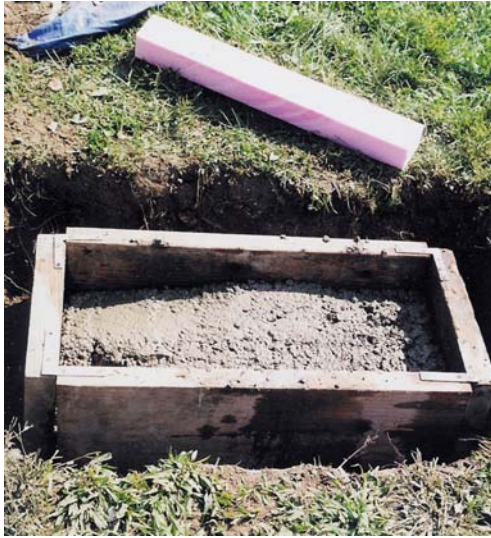
On left, a new base partially filled with concrete and foam setting form in background.

the ground. A better solution is the fabrication of a new below-grade base, to re-set the stone at a more reasonable height, allowing for the viewing of inscriptions and decoration. These are fabricated on site by casting in the ground with concrete, using a removable form insert to create a setting slot ($\frac{1}{2}$ " thicker and $\frac{1}{2}$ " wider than the marker); the finished top surface of the base should be entirely concealed by new topsoil, which is then seeded.

The bases are minimally 12 inches deep, 12 inches greater in thickness and 6 inches wider than the stone itself. Once the concrete has cured, forms are removed and the stones are reset into the slot as above.

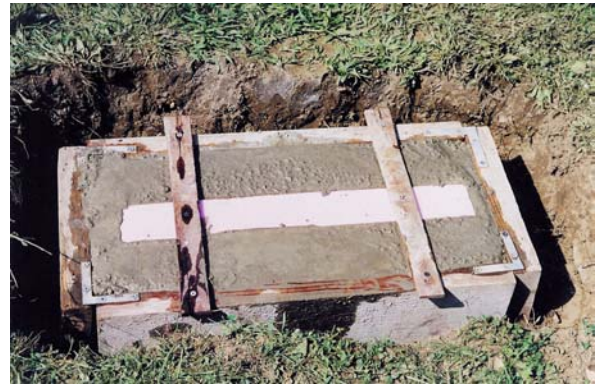
On the right, the poured base with setting form in place
